# Manhole Inspection Summary

Manhole # S47K\_\_014MH

Insp Date: **9/9/08 9:02 AM**

**Location** Address: **side 2321 leakin st**

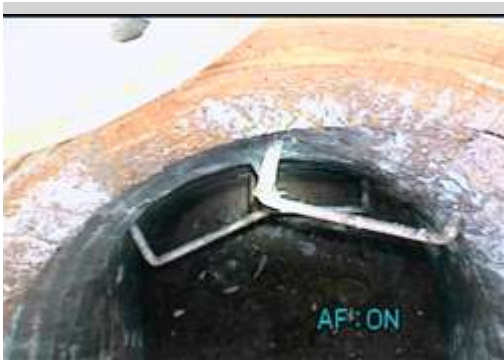
Defect 1

Count: **3** Missing: **0** ☒ **Corroded**

corr steps

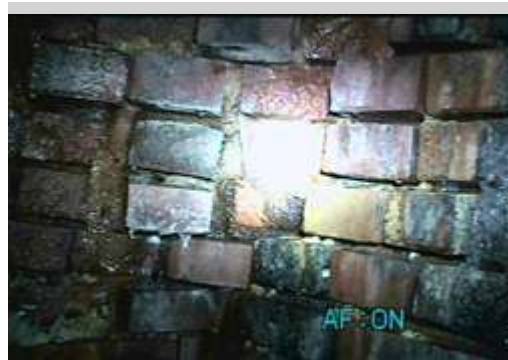
Defect 6

Condition: ☐ Sound ☒ **Cracked** ☐ Root Intrusion ☒ **Loose Brick** ☒ **Deteriorated**

Infiltration: ☐ None ☐ Joint ☐ Cracks ☐ Mortar ☐ Roots ☒ **Wall**

barrel infiltration, loose bricks

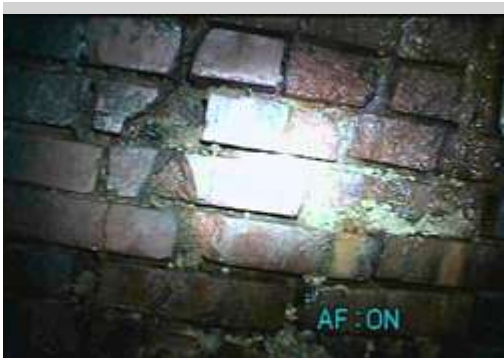
Defect 5

cracked barrel

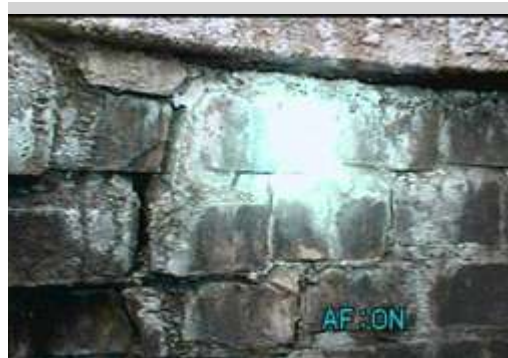
Defect 4

Condition: ☐ Sound ☒ **Cracked** ☐ Root Intrusion ☐ Loose Brick ☐ Deteriorated

cracked frame adj

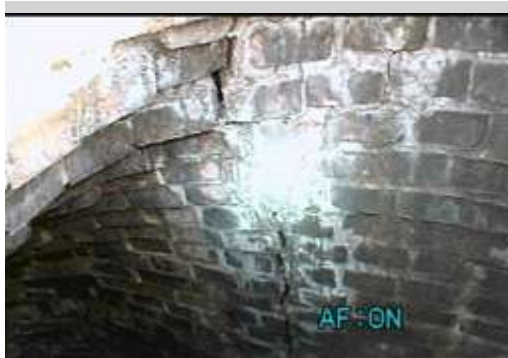
Defect 3

Condition: ☐ Sound ☒ **Cracked** ☐ Root Intrusion ☐ Loose Brick ☐ Deteriorated

cracked corbal

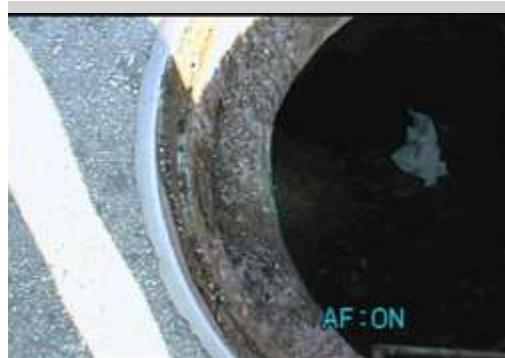
Defect 2

Offset: **2** (in.)

offset

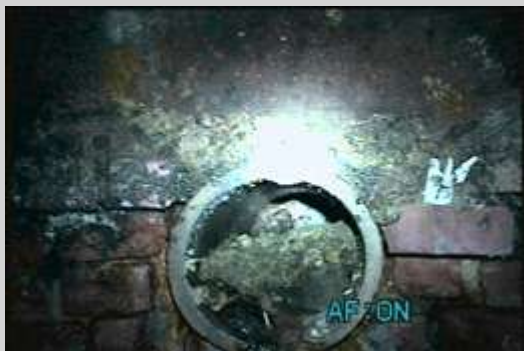
3 O'Clock Inflow

Deposits: ☐ None ☐ Mud ☐ Sludge ☒ **Debris** ☐ Grease

Silt Depth: 0 (in.) Deposits Extent: **Heavy**
